Detailed inspection, investigations, assessments and project management of works enabling exceptional convoy to circulate over a sensitive VIPP

Passage of 111-tonne exceptional convoy over a VIPP

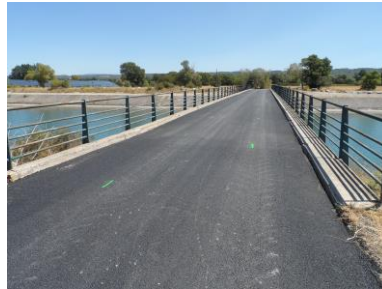
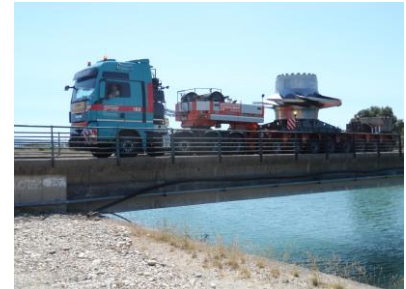
The structure is a VIPP (an independent span viaduct made of pre-tensioned prestressed concrete beams) that was built in 1966 and is therefore considered as sensitive.

The assessment revealed the need to smooth down the very thick layer of bitumen coating to enable the exceptional convoy to pass.

Project management of the smoothing out and restoration of the roadway.
