Inspection and diagnosis of the condition of the barge on dry dock "Forme 10" - Port of Marseille

Grand Port Maritime de Marseille (GPMM)

Barge for one of Europe's largest dry docks:
Length: 90 m
Width: 15 m
Height: 13 m

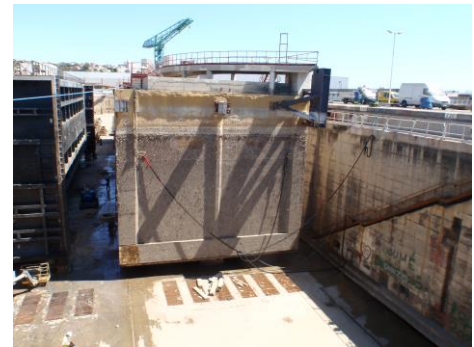
Perspective du bateau porte

The prestressed concrete barge on the "Forme 10" dry dock of the autonomous port of Marseille was built in 1973. Its principal dimensions are:

The structure is divided into 28 open caissons placed sideways along two lines. The caissons ballast the gate to enable the opening and shutting of Forme 10.
