Diagnosis of a prestressed reinforced concrete wall

NKP floating barge

Technical assessment of prestressed concrete hull girder subjected to shock

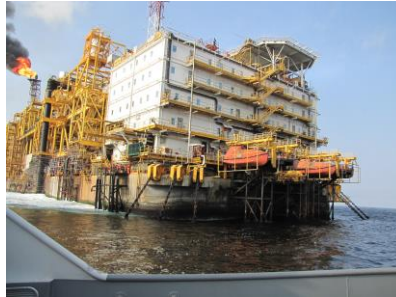
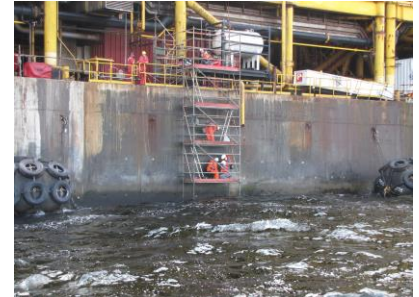
TOTAL owns a floating prestressed concrete oil platform off the coast of Pointe-Noire in the Congo.

The platform was built in Marseille in 1994 and was towed onto site.

On 30 January 2010, a logistics ship struck the exterior wall on the starboard side of the platform due to a wrong manoeuvre.

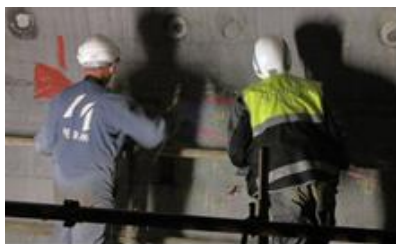
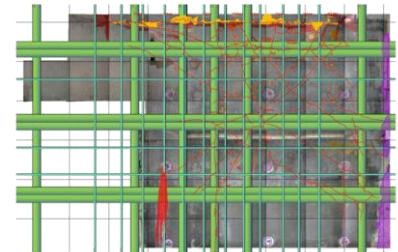
Carrying out of the diagnosis of a prestressed concrete hull girder of an operational oil platform.
